LPC# 1210500002 Marion County
Sandoval Zinc Co. - Sandoval
ILD 053 980 454
F/HRS

Expanded Site Inspection

Sandoval Zinc Company
Box 263 Smelter Road Highway 51, Sandoval, Illinois
ILD 053 980 454

April 5, 2010

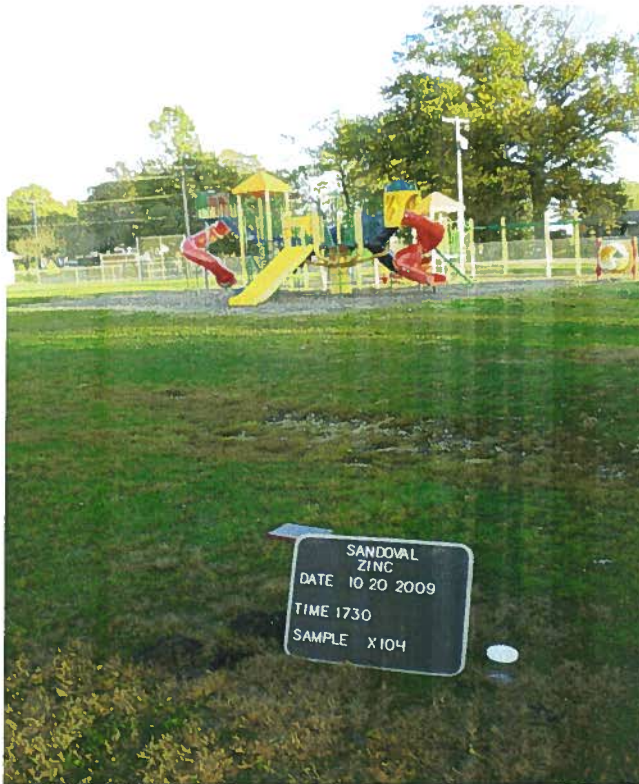
DATE: 10/20/2009
TIME: 1730
PHOTO BY: L. Range
DIRECTION: Southeast

Sample X104 was collected in the play area of the Sandoval elementary school. This play area is located to the south of the school. X104 was collected from a depth of 6 inches from a brown loam with fill material and debris.

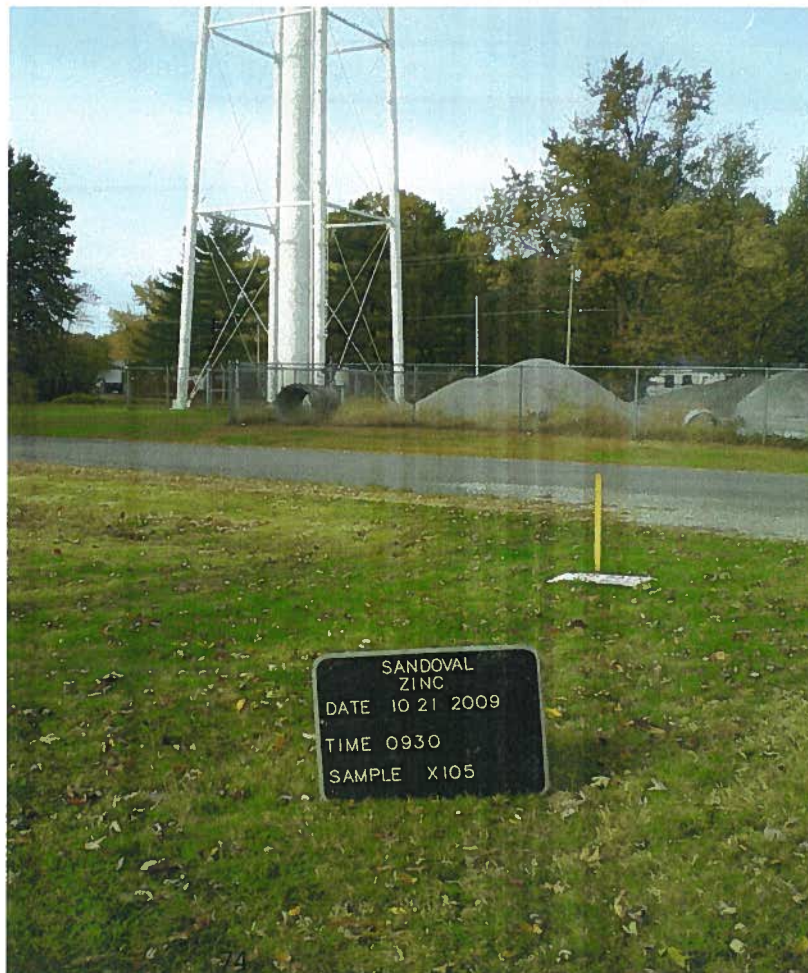
DATE: 10/21/2009
TIME: 0930
PHOTO BY: L. Range
DIRECTION: Southwest

Photo taken of sample location X105. X105 was located at the corner of a residential area just northeast of the watertower. X105 was collected from a brown silty loam interspersed with gravelly fill material from a depth of 6 inches.

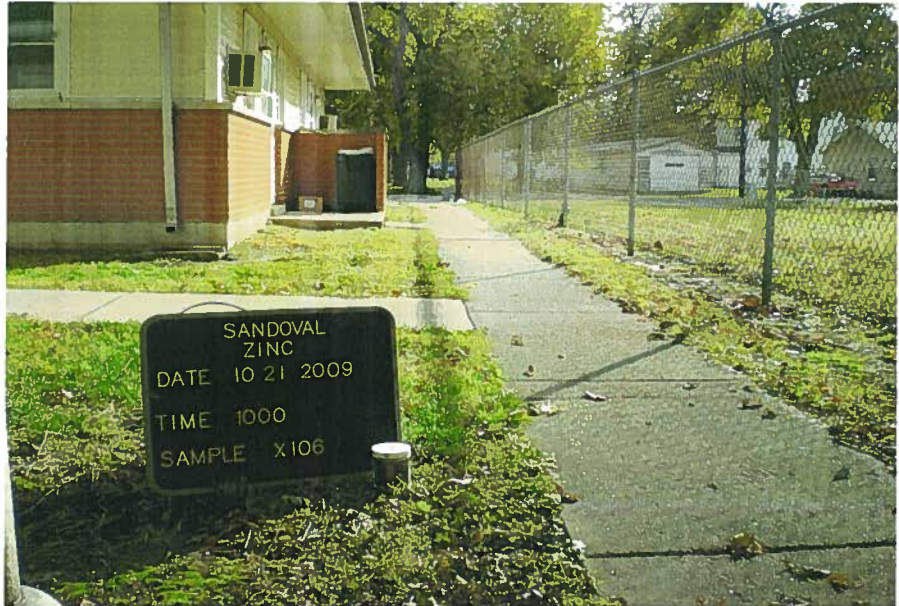
DATE:	10/21/09
TIME:	1000
PHOTO BY:	L. Range
DIRECTION:	East
COMMENTS:	
<p>This location is near Perry and Broadway. X106 was collected from the southwest corner of the property. Sample consisted of a dark brown silty loam from a depth of 6 inches.</p>

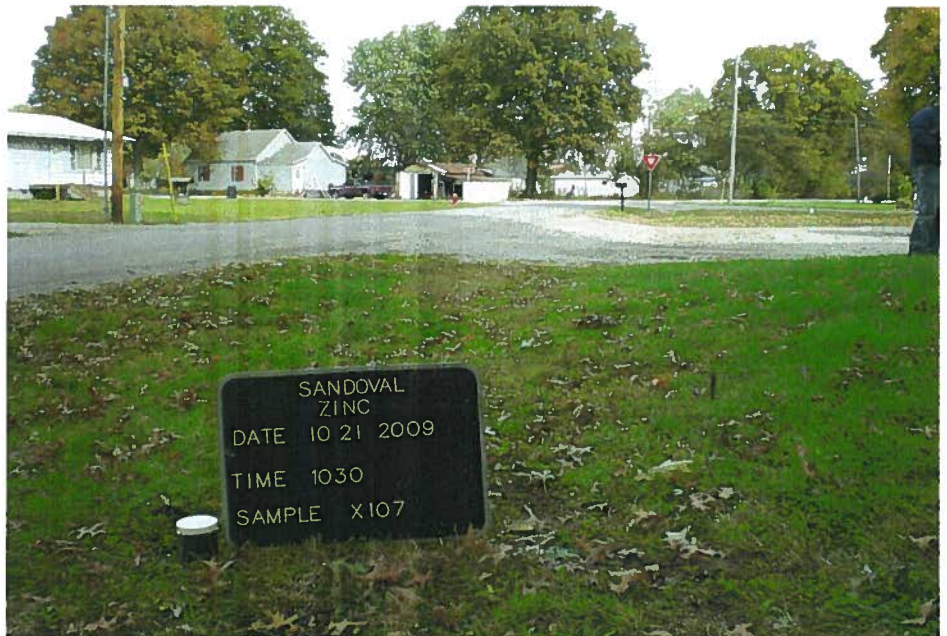
DATE:	10/21/2009
TIME:	1030
PHOTO BY:	L. Range
DIRECTION:	North
COMMENTS:	
<p>This sample location was taken from the western portion of public housing near Oak Street. This sample consisted of a brown cindery mix from a depth of 6 inches.</p>

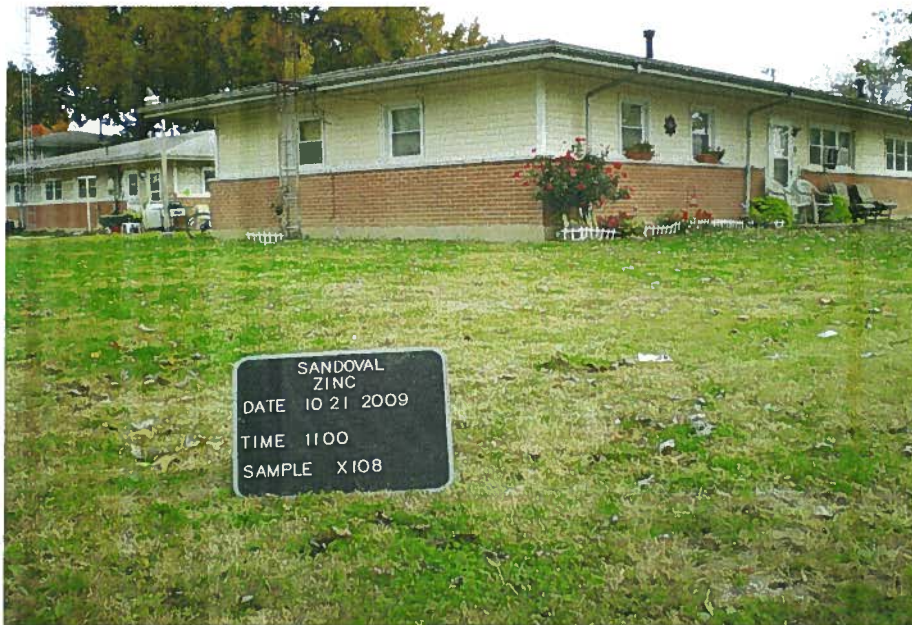
DATE: 10/21/2009
TIME: 1100
PHOTO BY: L. Range
DIRECTION: Northeast

This photow was taken of Sample X108 which was located on the southwest corner of the property (Mulberry Street). X108 was collected from a depth of 6 inches from a brown cindery loam.

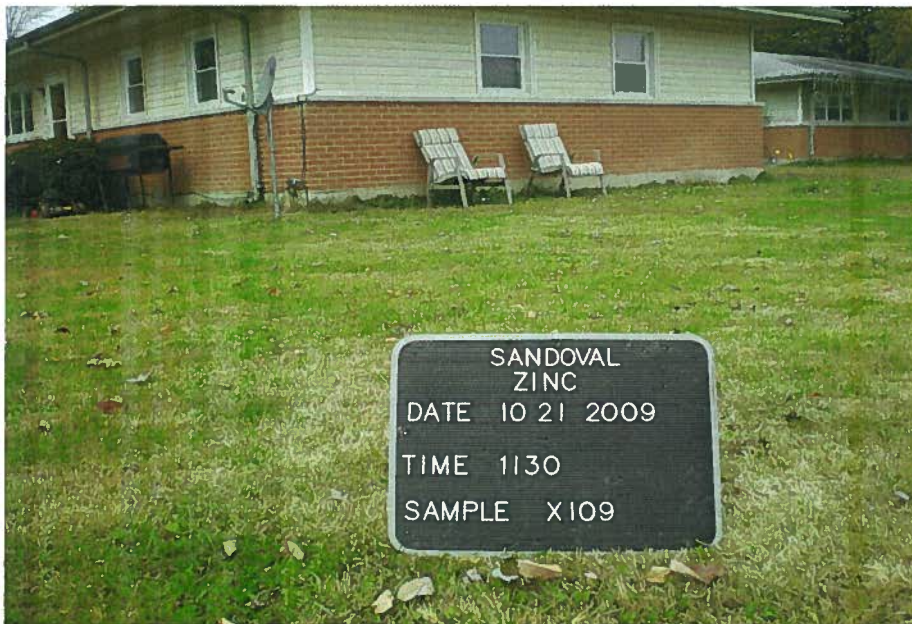
DATE: 10/21/2009
TIME: 1130
PHOTO BY: L. Range
DIRECTION: Northwest

This sample was located on the northeast corner of the public housing located on Mulberry Street. X109 was collected from a depth of 6 inches from a light brown silty loam.

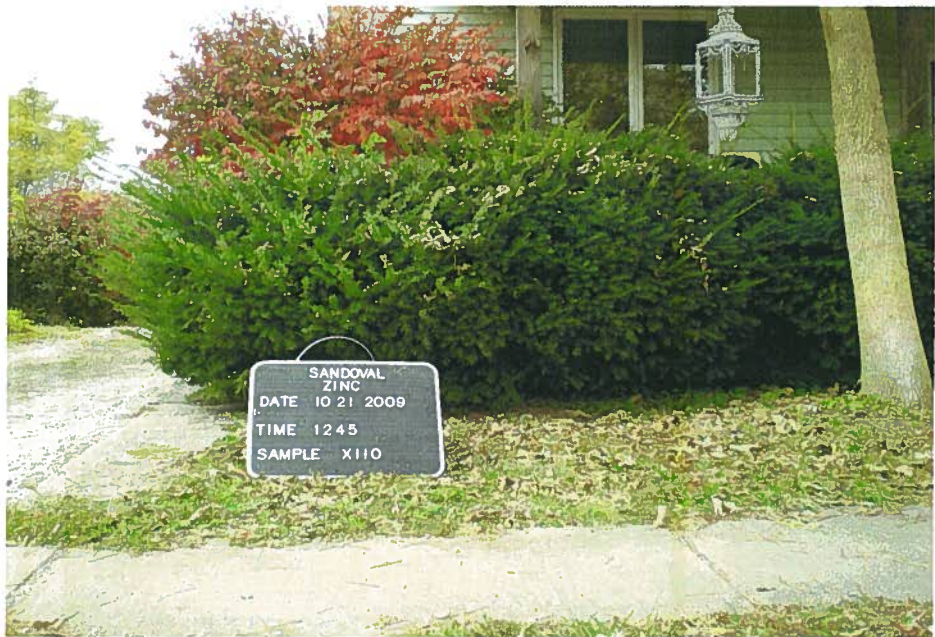
DATE:	10/21/09
TIME:	1245
PHOTO BY:	L. Range
DIRECTION:	West
COMMENTS:	<p>X110 was collected from a residence located along Mulberry Street from the front yard. X110 consisted of a brown silty loam from a depth of 4 to 6 inches.</p>

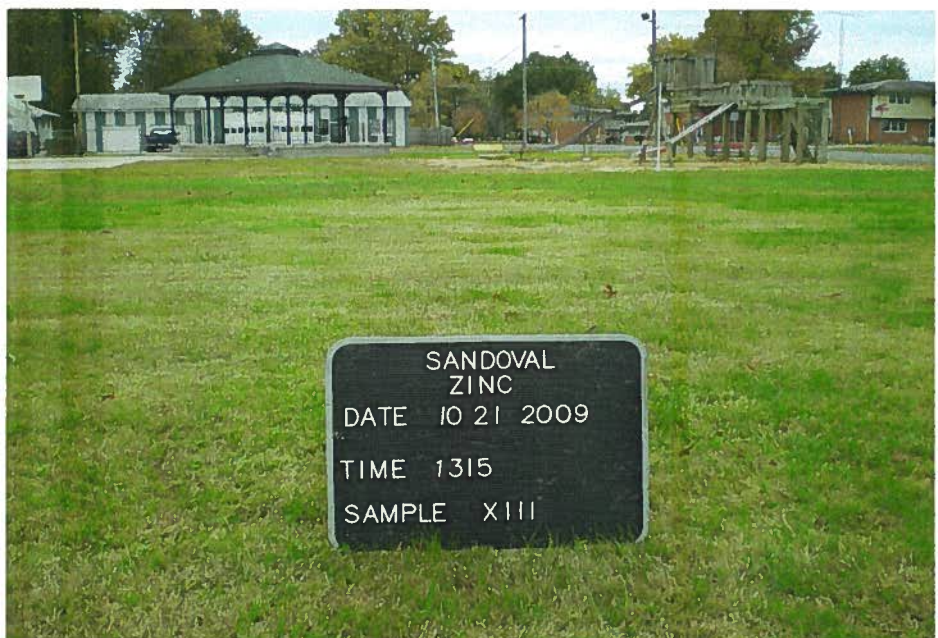
DATE:	10/21/2009
TIME:	1315
PHOTO BY:	L. Range
DIRECTION:	South
COMMENTS:	<p>Photo was taken of sample X111. This sample was collected from the public park. X111 consisted of a brown silty loam from a depth of 4 to 6 inches.</p>

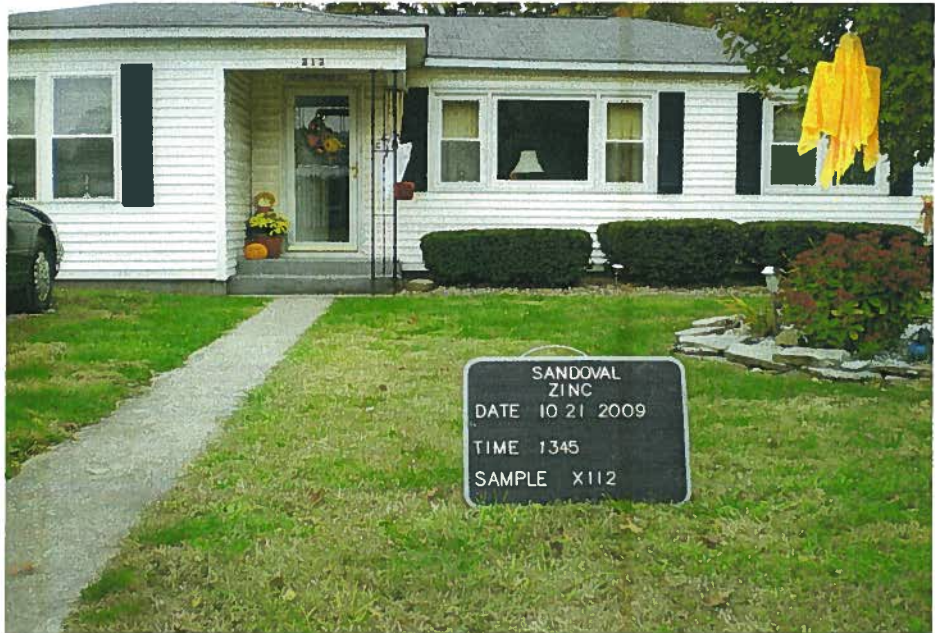
X112 was collected from a residential property located along Mulberry Street. X112 consisted of a brown silty loam with cinders from a depth of 4 inches. This sample was collected from the front yard.

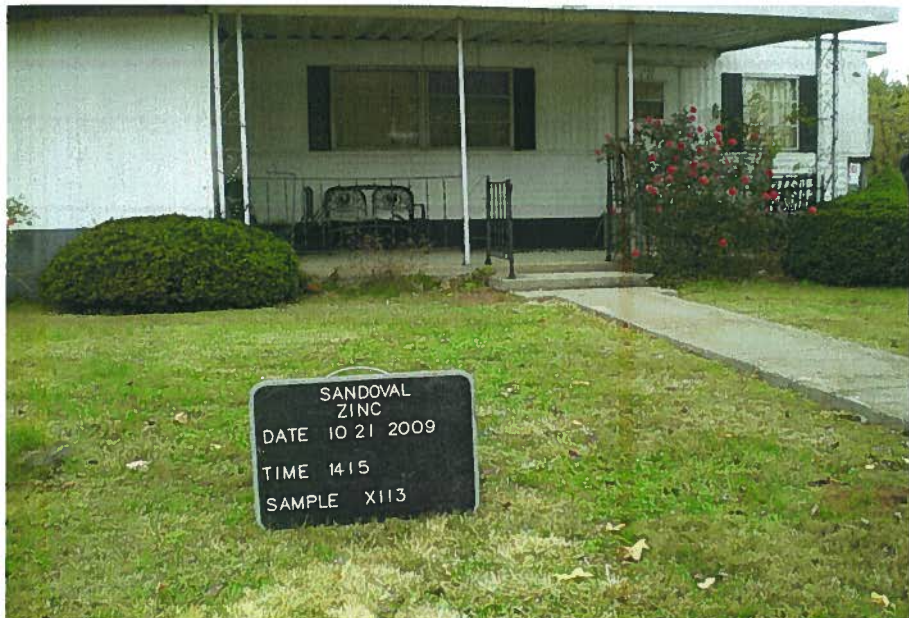
DATE: 10/21/2009
TIME: 1415
PHOTO BY: L. Range
DIRECTION: North

Photo was taken of sample X113. X113 was collected from a residential yard located on Arizona Street. X113 consisted of a brown silty clay with cinders from a depth of 6 inches.
